Abbey Quarter Kilkenny City

Conservation Management Plan

January 2023

6.0 Condition Survey

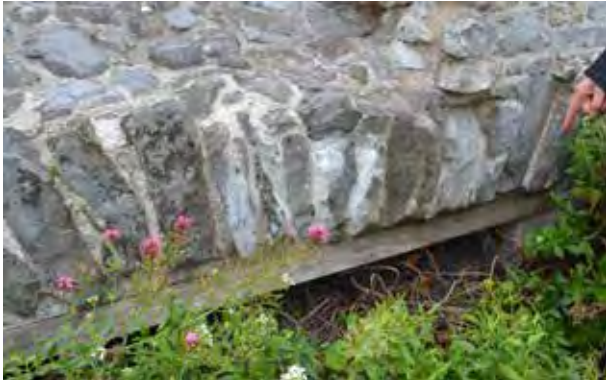
Of the blind arches that once existed on the inner face of the city wall, only one remains intact and visible just above ground. A new timber relieving beam was inserted below this arch during the 2016 works to stabilise the structure. This was

Fig 62. New timber supporting relieving arch in city wall

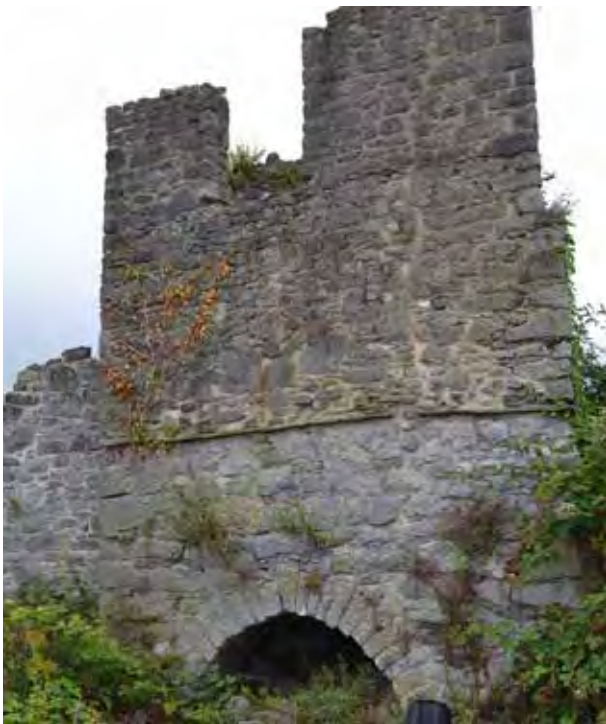
Fig 63. Facade facing the Abbey quarter site

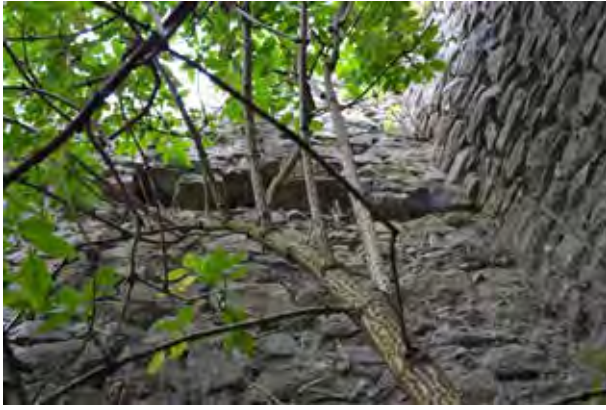
Fig 66. Large tree growing in the interior of Evan's Turret

from the outside. The inner skin and wall core has partially collapsed in the south western corner, leaving a stepped wall up to the upper floors. On the inner side of the north wall there are numerous areas of loose masonry with pockets where stones have fallen out of the wall core. There is still evidence of joist sockets in the wall where the original level of the guard tower would have been, and there is further evidence then of the higher floor level and associated drainage which were inserted when the tower was used as a prospect tower in later centuries. Partially buried embrasures in the northern and eastern walls with arrow slit windows looking out onto the river are now filled with earth.

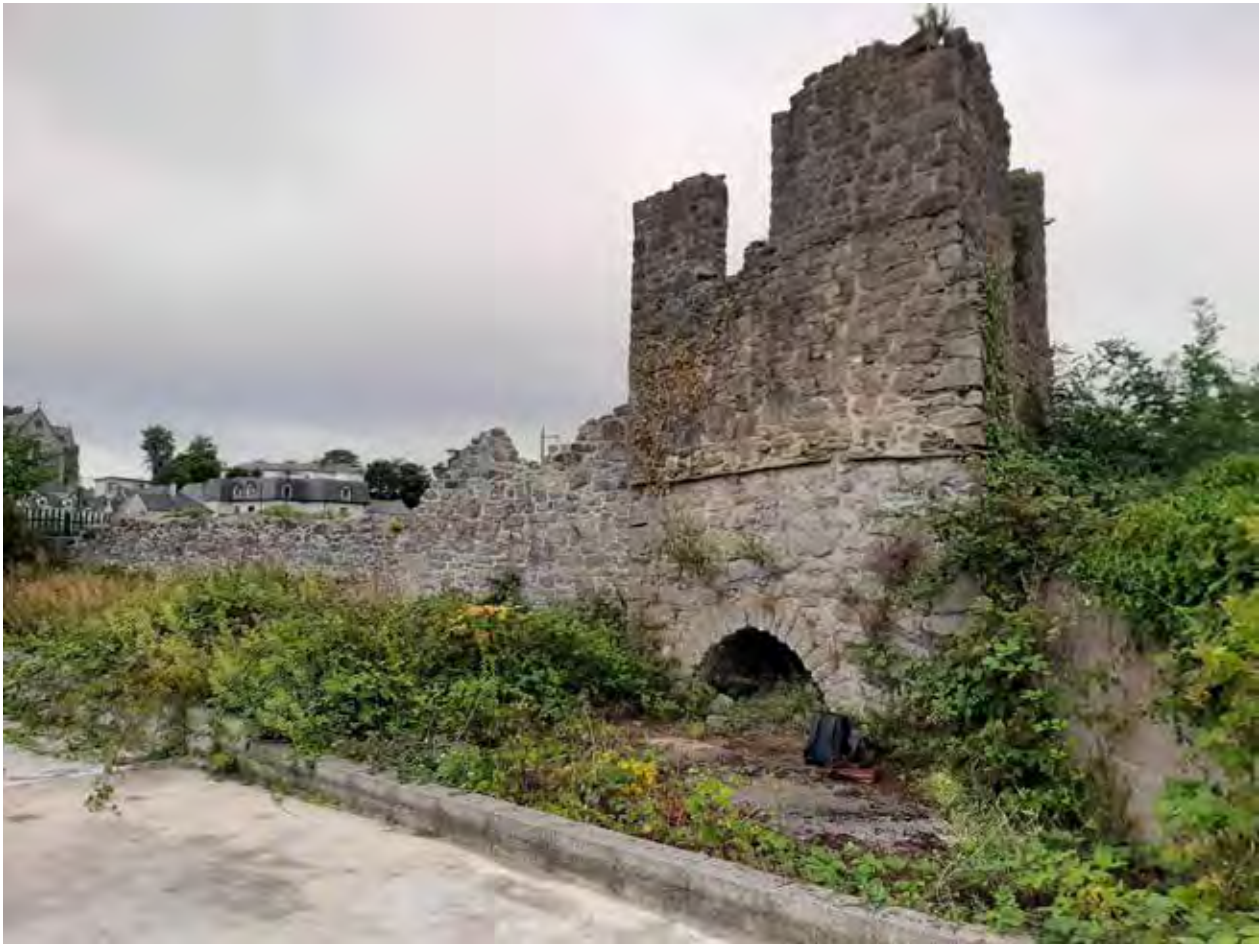
Vegetation in general is a problem for much of the surviving masonry on the site, particularly to the turret and the city wall. Though a substantial amount was removed during the 2016 conservation works it has now returned and is beginning to engulf the structure once again.

Fig 69. Evan's turret following restoration works. Vegetation has been allowed grow back over the site

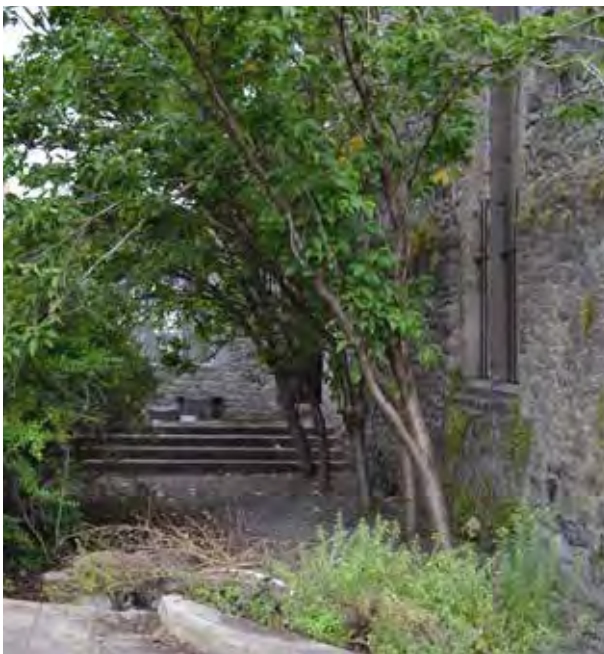
Fig 78. Large trees growing between the south wall and the tasting rooms

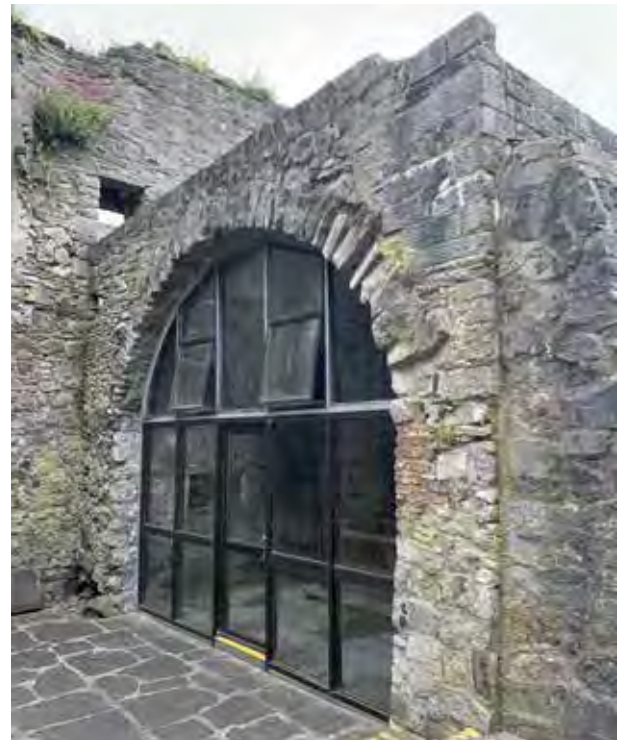
Fig 79. In-filled glazing system into the Sacristry'

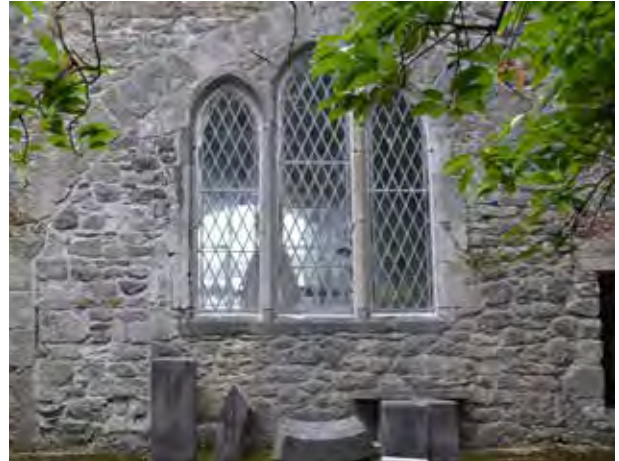
Fig 82. External view of the sacristy east wall , showing the infilled arch and window

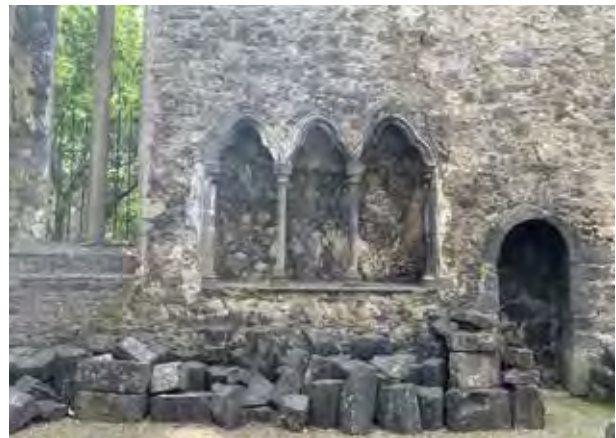
Fig 94. The sedilia in context with loose stones in the abbey strewn about.

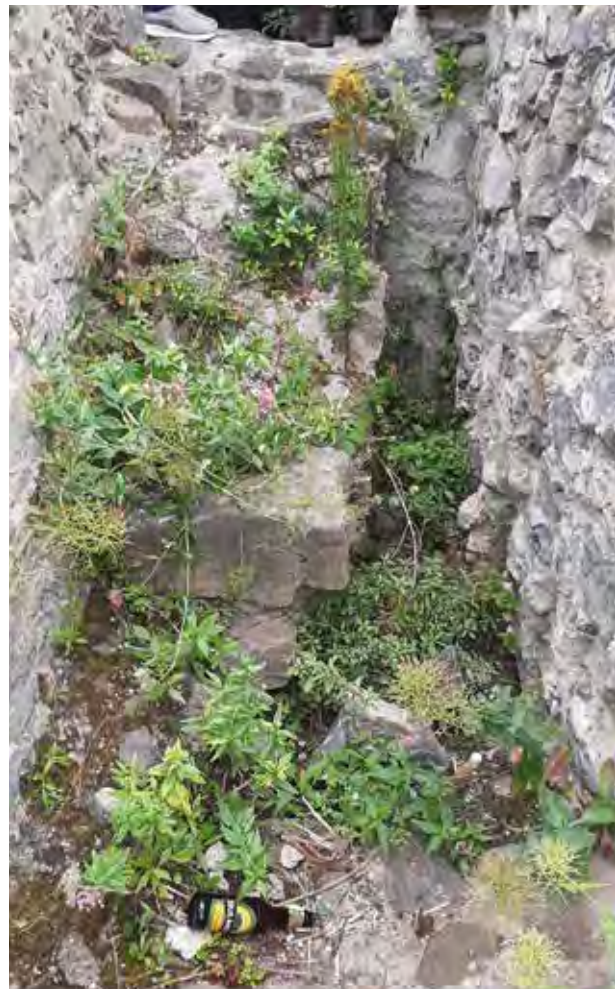
Fig 103. Vegetation growing on the wall walk within Evan's turret.

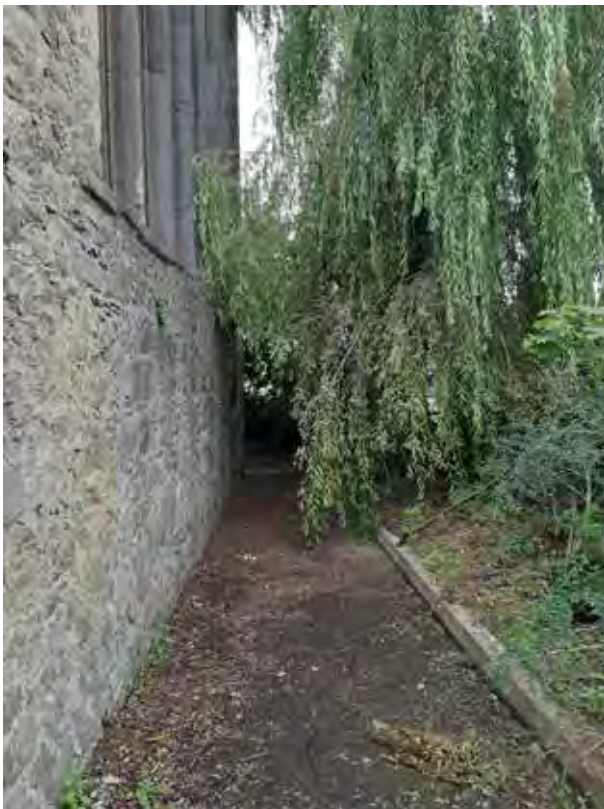
Fig 104. Willow tree to the east to be either strictly monitored or removed.

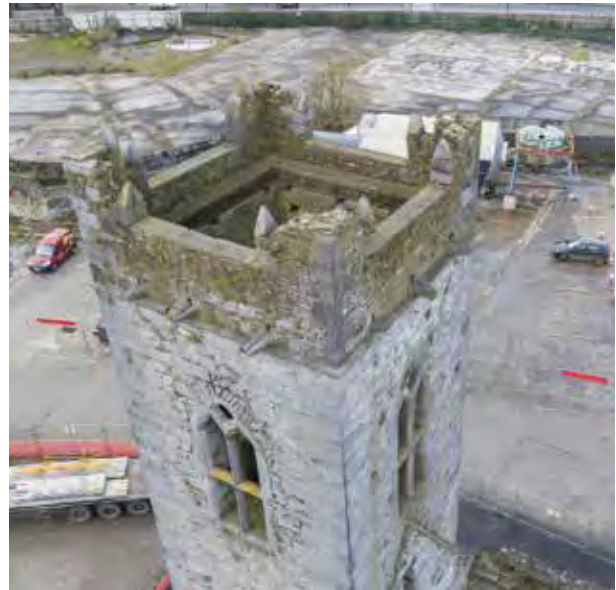
Fig 105. Tower stability to be investigated and monitored (Courtesy of the Photographic Archive, National Monuments Service)

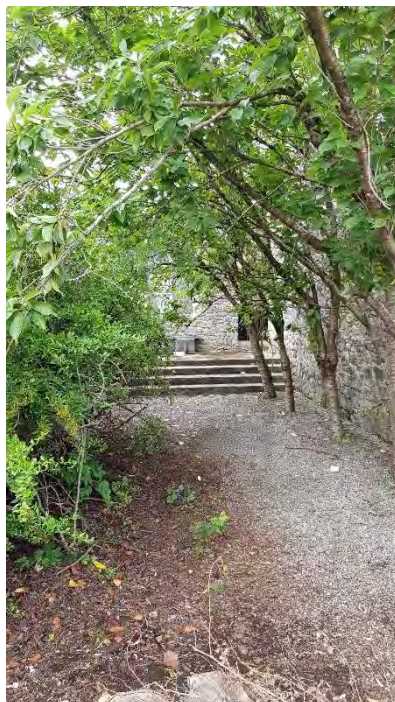
Four cherry trees growing close to the base of the south wall

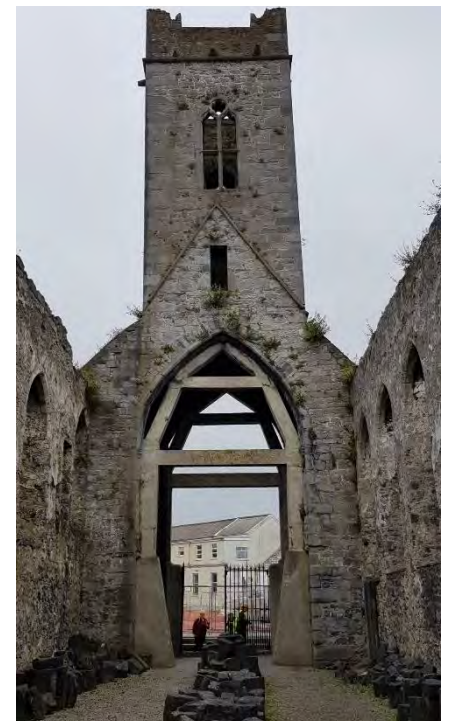
Reinforced Concrete frames under both arches supporting the tower

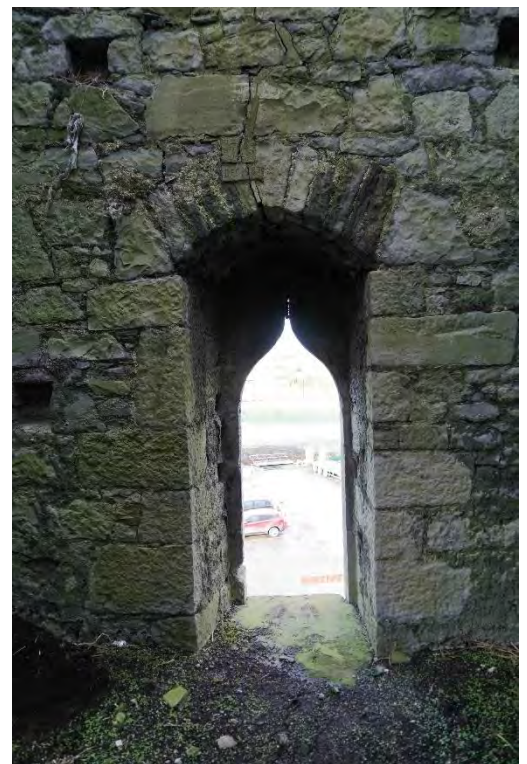
*View thro doorway into tower looking north
Note debris build-up. Photo c/o Chris*

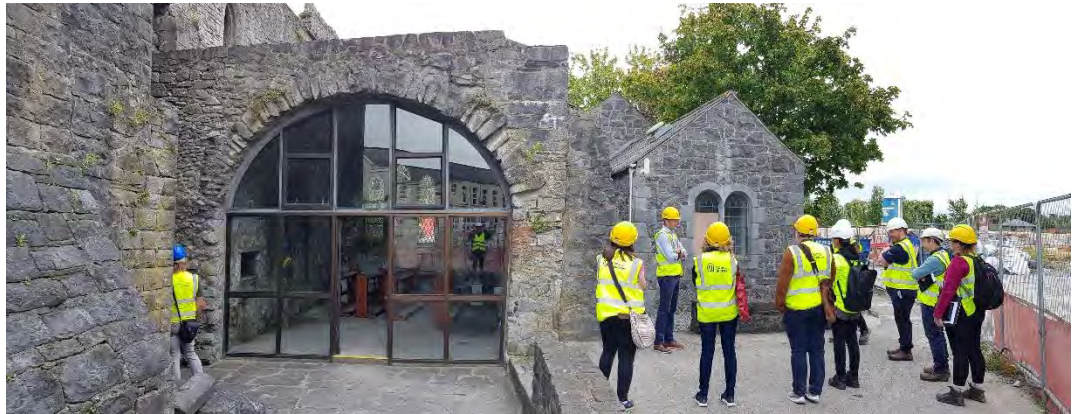
Sacristy – note little overburden to arch and lean of right-hand side supporting wall.
