Abbey Quarter Kilkenny City

Conservation Management Plan

January 2023

6.0 Condition Survey

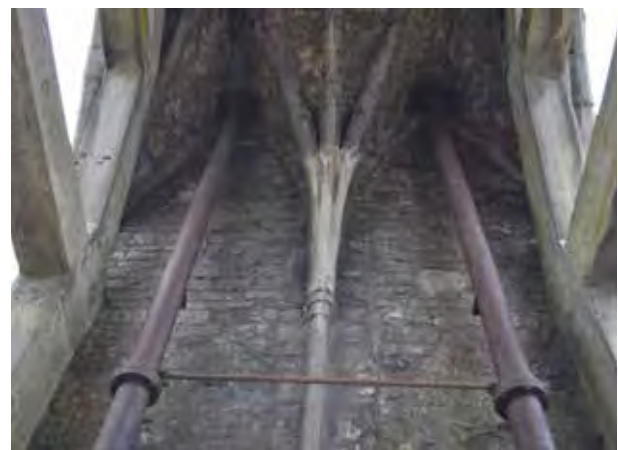
Fig 34. Cast iron columns on the south side of the crossing tower

...as winter was coming on, and there was the greatest danger in further delay, the Committee thought it advisable, at least, to prop the tower at once. With this view they had got two strong metal pillars cast at Waterford, at the expense of £24, and these were now in course of being erected under the south side of the tower arch, where the masonry was giving way... (Anon 1868c, 141).

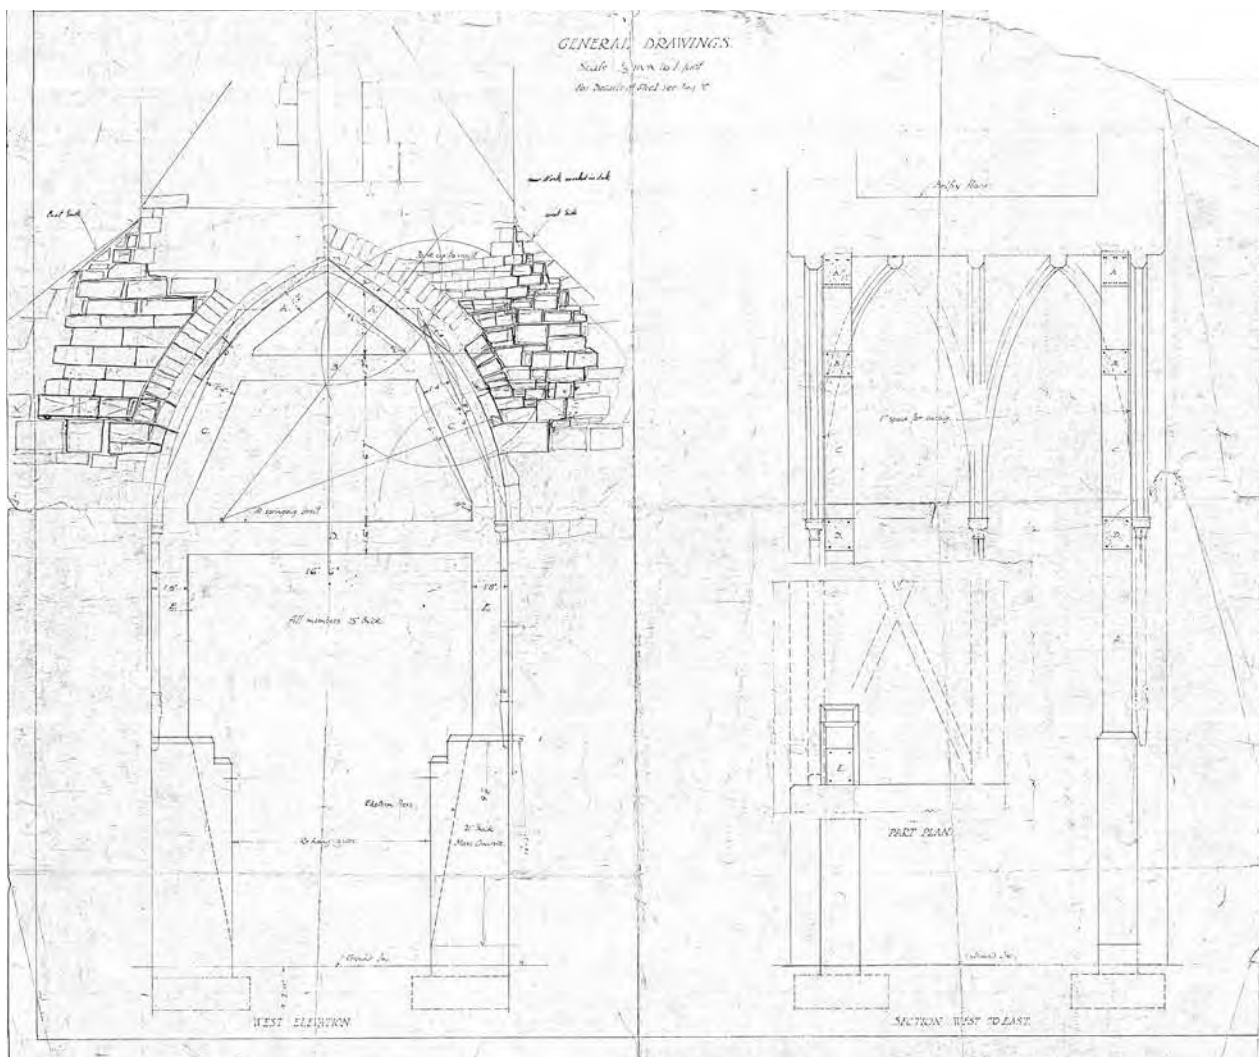
Fig 35. General drawings from 1927 showing the proposed concrete structure to the underside of the Tower (OPW Archive)

photograph from 1926 shows this timber centring under the eastern arch. Over the coming years, the OPW reports mention, but do not specify the nature of, works carried-out at the site. Around 1927, the timber centring was replaced by a similar reinforced concrete centring. In the OPW archives there are two drawings, one dated September 1927, that show the proposed centring as it survives today. This reinforced concrete centring is inside the line of the earlier timber centring, which was most

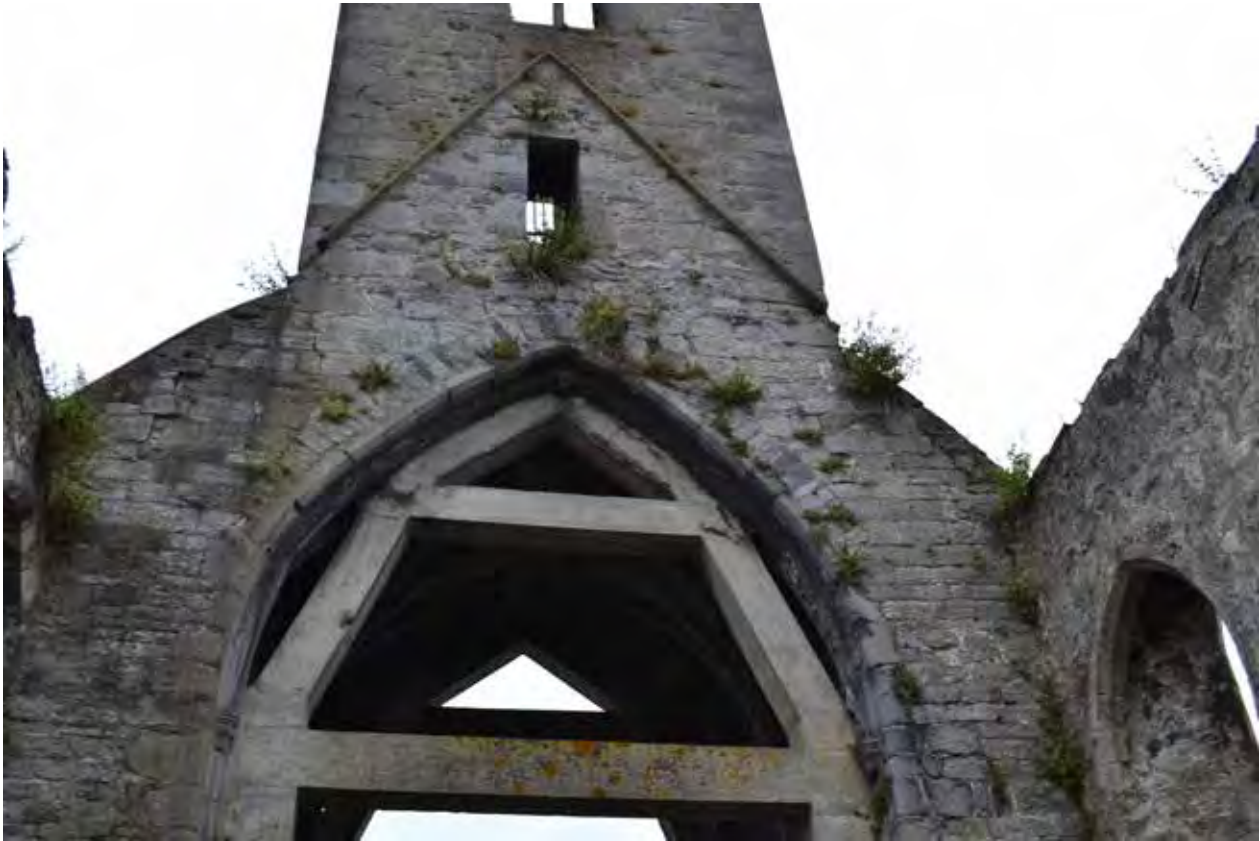
Fig 36. The concrete supports in-situ today

The tower contains an early twentieth-century conservation intervention in the form of a double concrete frame, inserted to stabilise the structure (Fig 36, 89). Matching concrete frames sit within the west and east tower arches for a similar purpose, as cracks were observed at the haunches of the pointed arch below the tower. Two iron columns were installed within the south side of the tower in the late nineteenth century to support the groin vaulting above. These are fixed into the masonry with iron ties, while some of the rib vaulting has been removed to the underside of the vault to accommodate the column tops. It is unclear what these structural interventions are doing today, in terms of support to the tower structure, but the tower is notably leaning towards the south, and this lean is visible on the survey drawings recently obtained by the OPW. Removal of the concrete

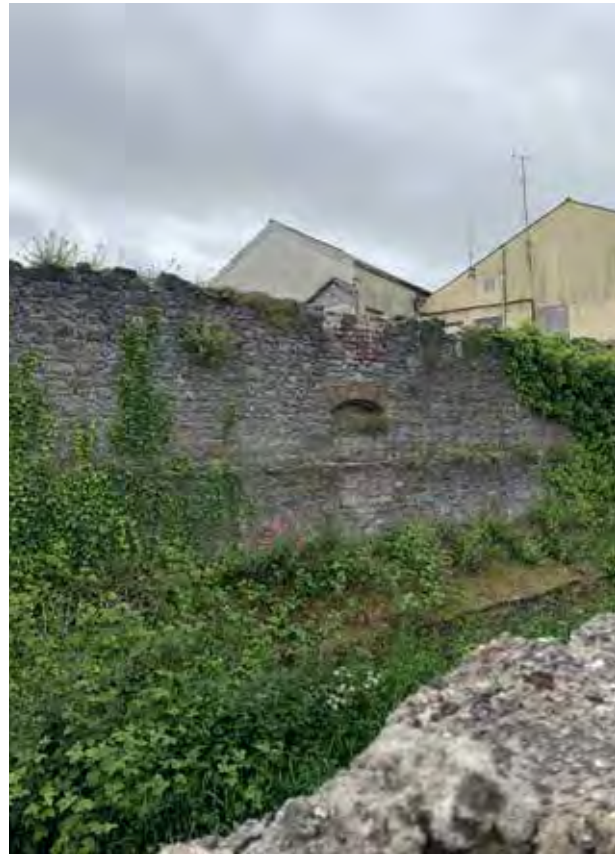
Fig 55. City Wall with the remains of the Horse barracks building built on top.

notably with the insertion of the Horse barracks during the eighteenth century and the development of the Smithwick's Brewery throughout the late-nineteenth and twentieth centuries. Poor workmanship in the section of wall to the north-west of the site, where arched brick window surrounds are still visible, detracts from the character and appearance of the wall and its significance. The principal architectural significance of Evan's Turret and adjoining walls lies in their being part of an important linear monument, part standing, which once enclosed the city. Considered holistically the standing monument, together with buried and missing sections define the outer limits of the medieval town. The later aesthetic use of the river-side turret as a belvedere, adds another layer to the architectural, historical and social significance of the place, which contributes much to the historic character of this ancient walled town.

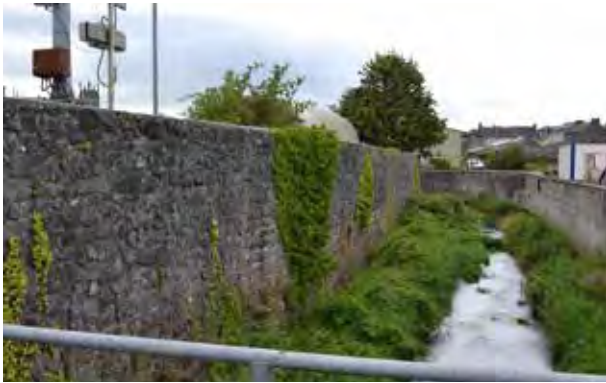
Fig 57. This wall was built on the precinct wall for St Francis' Abbey which effectively formed part of the defences for the city

construction it is difficult to discern exactly when it might have been built. This section of the wall is capped with a cement render with metal trunking for pipework and cables fixed to the top of the capping. The pointing in this whole upper section is mostly cementitious. Along the northside of the wall rushes grow at the base of the wall on the river side, obscuring the condition of the masonry in this location. There are areas of extensive vegetation growth along the wall, and as the wall rounds the sharp bend in the river, older masonry is visible on the north side at the corner of the wall. Overall this section of the wall is in reasonable condition, and has been subject to rebuilding and repair. The cement render should be removed and a more appropriate capping provided.

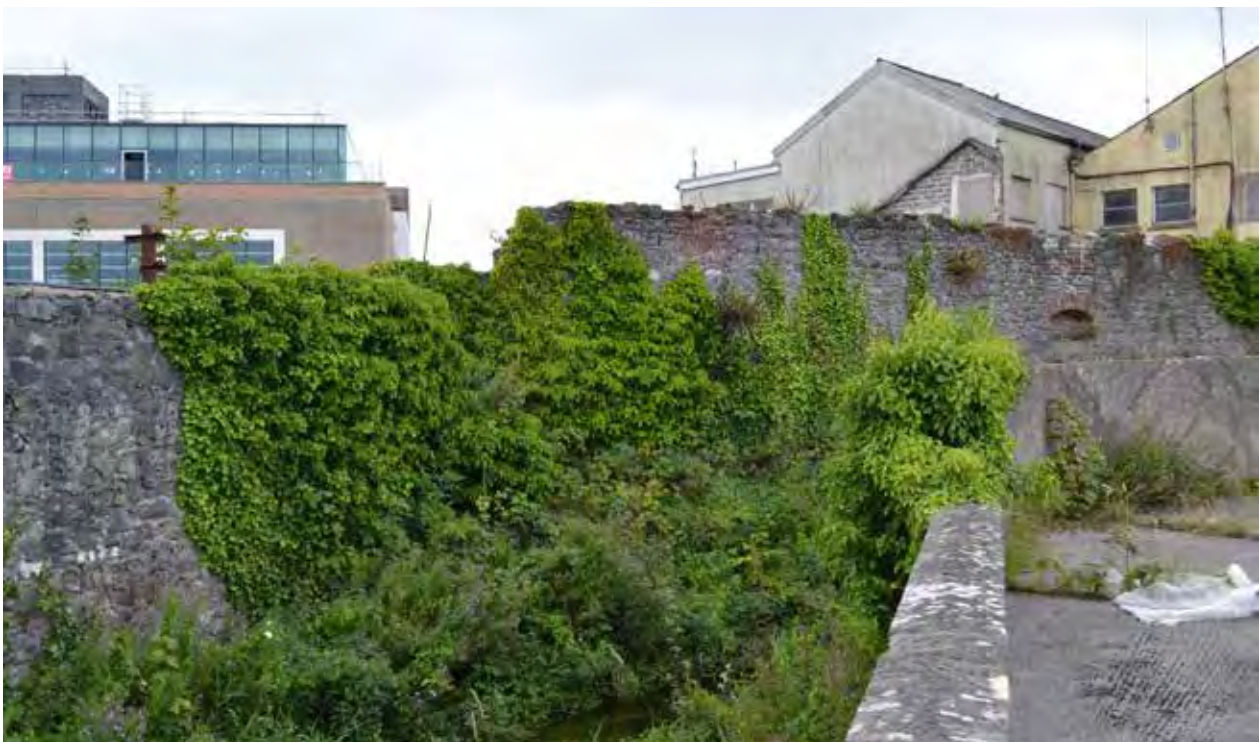
During recent demolition works to the Mayfair Building and new ESB substation, the south side of the wall facing the site was cleaned of vegetation and repointed with lime mortar. There are also still some remnants of lime plaster clinging to the walls at low level on this side of the building. However, the north side of the wall facing the river is in a worse state, with large amounts of thick vegetation having taken root in the wall, and severely eroded brickwork in the eighteenth-century wall.

Fig 58. Bend in the river where the remains of the Horse Barracks Building was built on top of the city wall

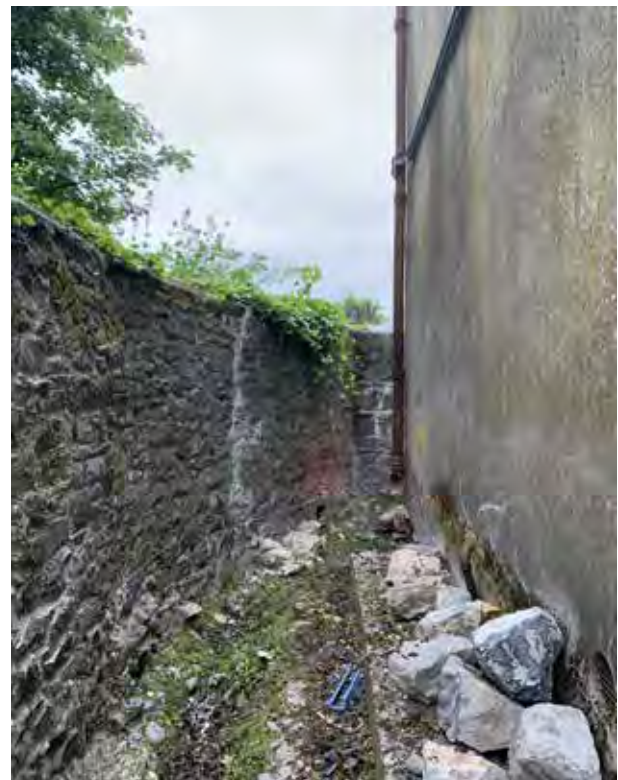
Works were undertaken to repair this portion of the city wall, which was cleaned and repointed using lime mortars and capped with a lime and sand flaunching. The north side of the wall is in a poorer condition, with a vegetative growth and open joints, and works to the side of the wall were excluded from the recent Mayfair contract. Notably on the north side of the wall there remains a remnant of an arch from Cotteral's Bridge (SMR KK019-026102-) that once crossed the river at this point. The abutments of the arch are visible on both sides of the River Breagagh.

Fig 60. The Mayfair section of the city wall, showing the narrow passage-way between the May fair building and the city wall bounding the River Breagagh'

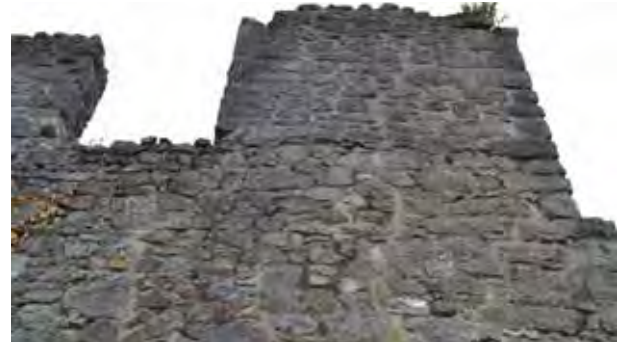
Fig 64. Detail of the facade of Evan's turret showing the different layers of construction

slate or possibly sandstone on the south wall at the level where the original guard tower's floor would have been originally situated. The stone above this course is slightly darker and was possibly built at a later stage than the lower level.

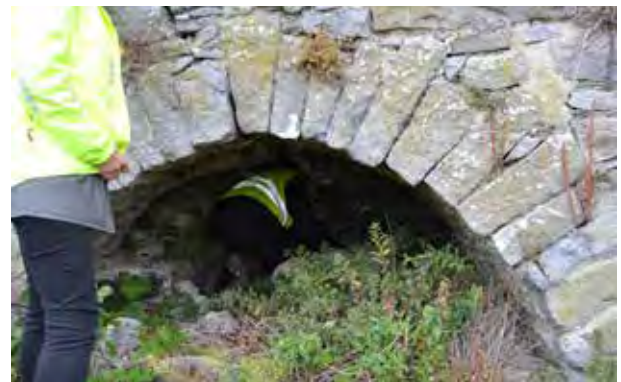
springing point of the arch. This pleasing arch consists of stone voussoirs and a keystone sitting within the un-coursed limestone wall of the tower. Cement pointing is still evident on the lower level of the tower, one part of which includes the date of 18th June 1979, when it was carried out. A number of small window embrasures, in what would have been the ground floor of the tower, are now partially buried in the ground.

Fig 65. Arch below Evan's Turret

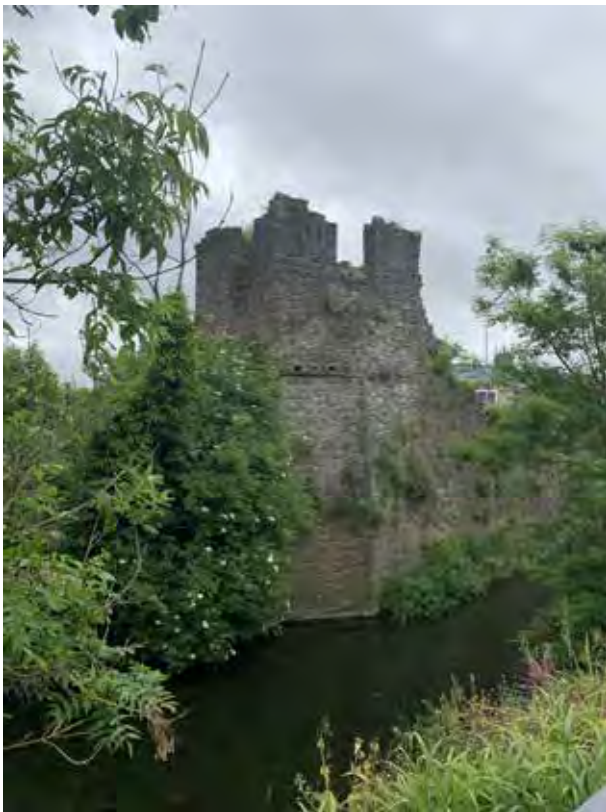
Fig 67. Evan's Turret from the north

A substantial tree is growing out of the eastern wall with thick roots embedded in the masonry. This is undoubtedly a cause for structural concern and should be removed and the masonry repaired as soon as possible.

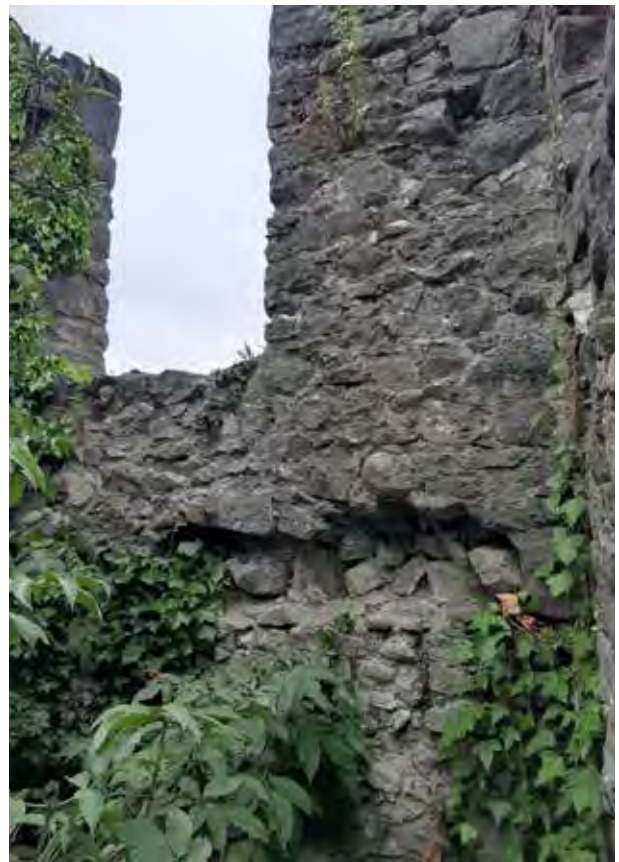
Fig 68. Interior of the turret showing locations where floor timbers may originally have been

Flowers and plants are now growing from the wall on the north hand side facing the river, and while attractive, if left to grow and flourish they will destabilize the structural integrity of the wall. On removal a certain amount of vegetative growth could be maintained on this wall, possibly through soft topping to encourage pollinators. To the south, thorn bushes, nettles and weeds are now growing prolifically adjacent to the recently repaired wall. This is most likely as a result of this area being fenced off combined with a lack of regular, on-going maintenance.

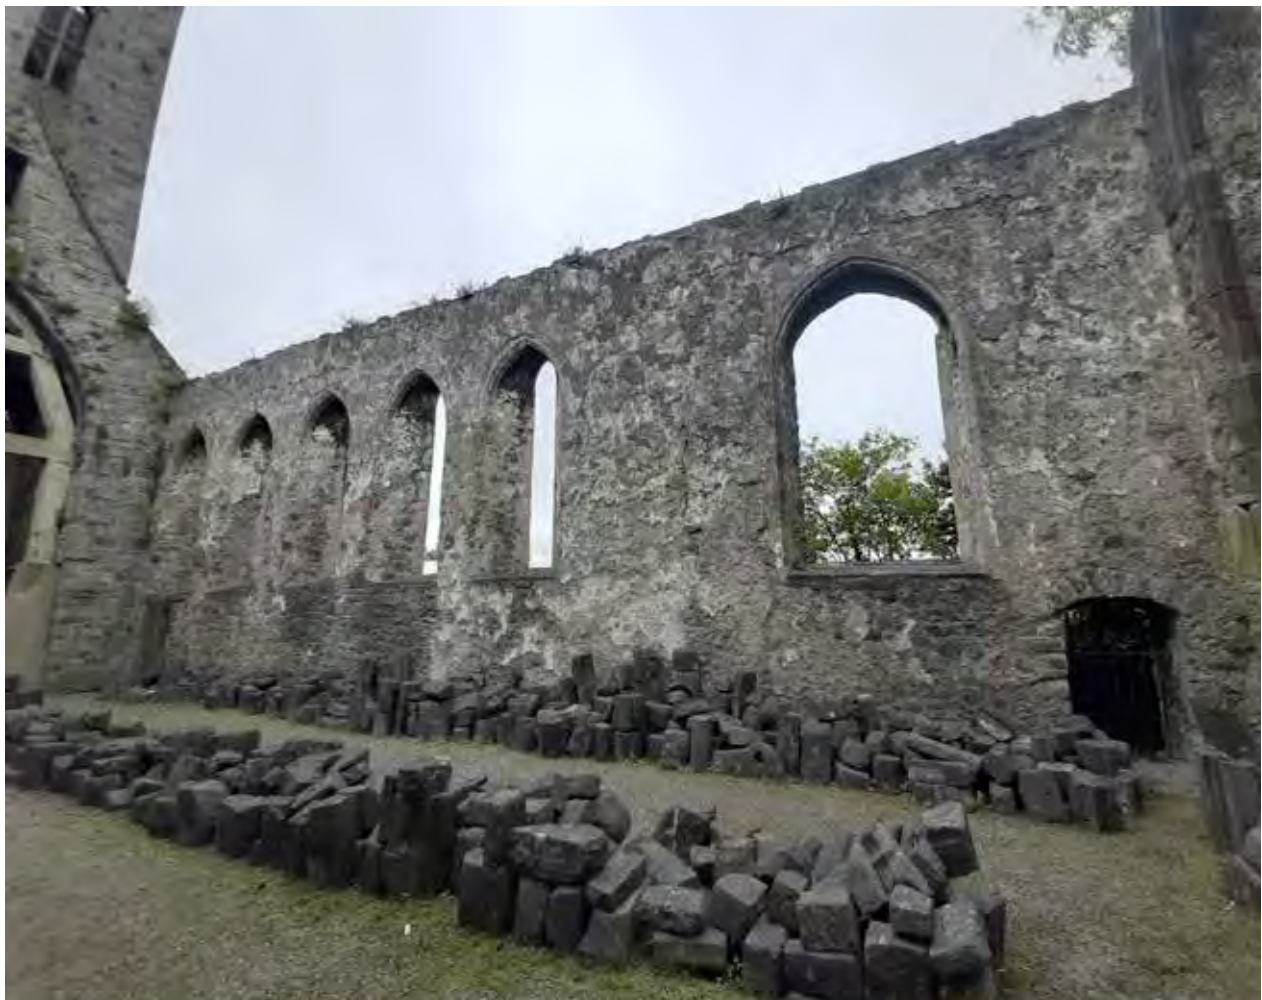
Fig 70. Interior view of the north wall of the choir

The impacts of the brewing industry are evident in the black sulphate deposits within the window heads, and cement pointing and repairs, which are also visible on the walls.

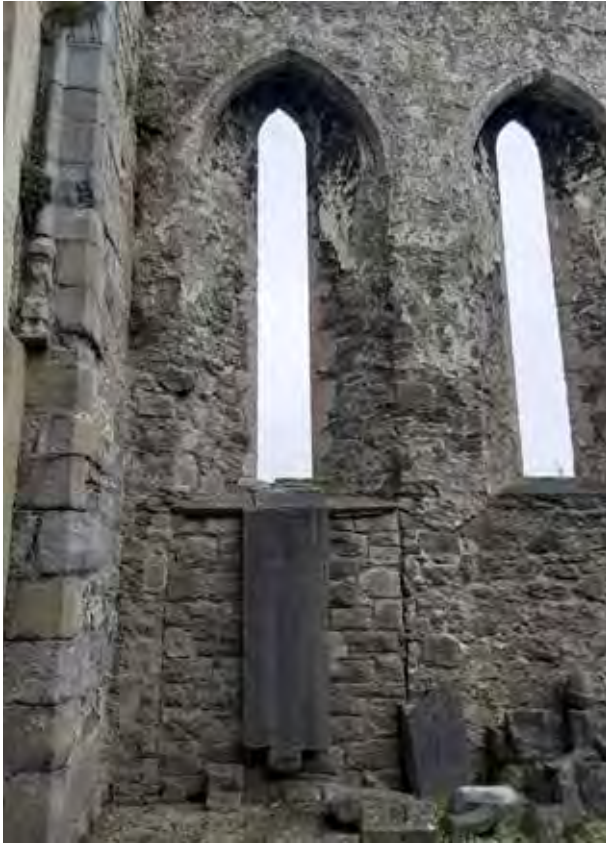
Fig 71. Opening made in the nineteenth century to allow access through to land behind it

A rusting metal gate, pocketed into the side walls and fixed shut at the base, has been inserted in an opening at the east end (Appendix C, feature 31). The stone threshold to this doorway has been badly damaged and until this is repaired, should not be used as a safe access point. Directly west of this opening there is a low level relieving rubble arch, which is now almost completely concealed below ground.

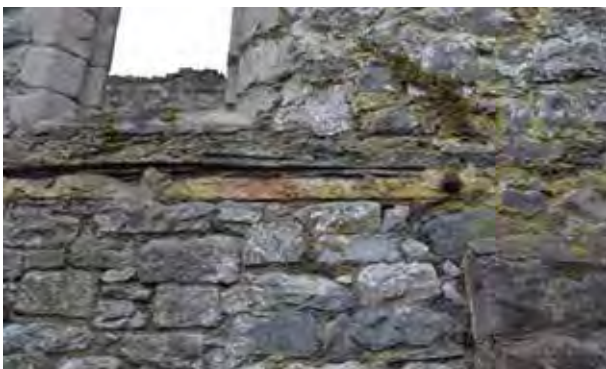
Fig 72. Corroded metal beam where a new opening was made in the wall

This was probably installed to help spread the load on the walls from the window opening above.

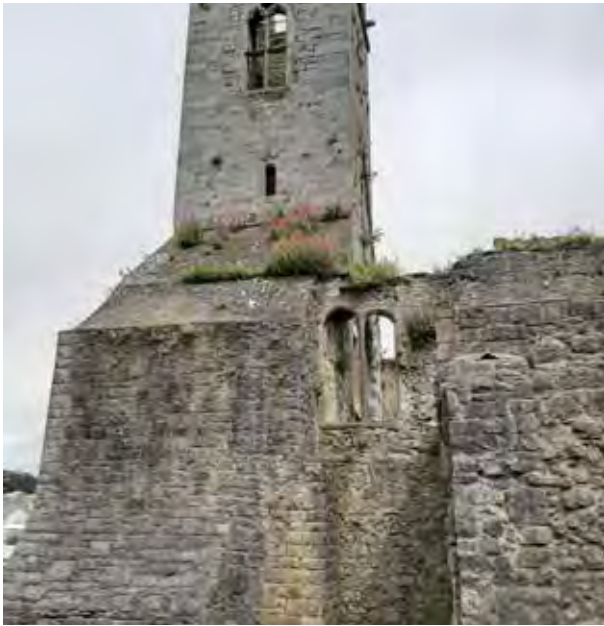
A masonry buttress to support the tower was possibly built as part of the conservations works to the tower carried out during the late twentieth century. There is evidence of mortar loss and

Fig 74. Newer buttress to the south of the tower

washed out joints to the lower portion of the buttress, and vegetation has begun to encroach into these open joints.

Photographs from the nineteen sixties show what would have then been a new cement rendered capping to the angled top portion of the buttress. While still intact, movement in the wall and buttress has resulted in several large cracks opening up in the cement, some along lines which are evident in these earlier photographs. A large amount of plant growth now lies along the fault line where the buttress meets the original wall of the abbey, and also where the angled wall meets the base of the tower. Rainfall down the eastern side of the buttress is causing staining to the stone and wash-outed masonry joints. These open cracks are also allowing water access into the buttress core which will destabilise the buttress.

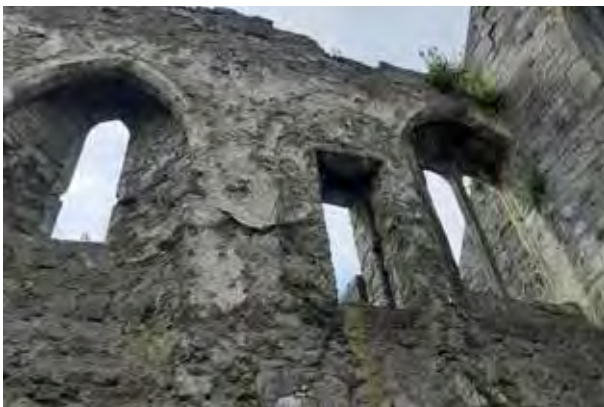
Fig 75. View of the altered windows in the south wall from inside the Abbey

Directly east of the tower buttress is a double arched lancet window located at high level, though unusually the two arches are of unequal size, indicating a modification to this window. The west arch is mis-shaped and smaller than its neighbour, and sits in close proximity to a semi-circular recess in the wall which may have once accommodated a spiral staircase (Fig 74). Below this recess there is a large amount of vegetation, which should be removed in order to prevent further damage to the window. The stonework below the window is in fair condition, most likely due to its location, protected by the oratory. Evidence remains of what appears to be lime render on lower eastern parts of the wall below the window, and this should be tested to determine its age and composition.

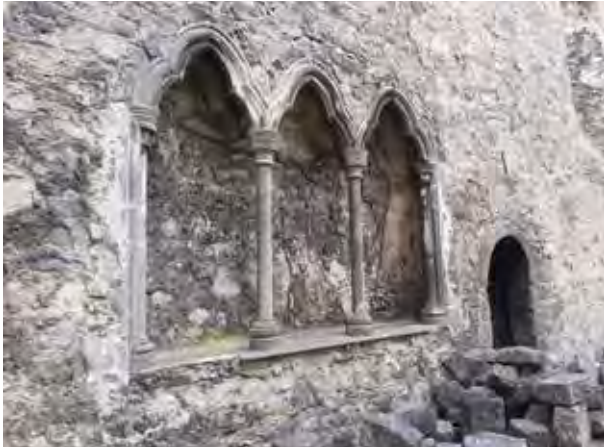
Fig 77. Sedilia window and opening into the south corridor

A blind triple sedilia (fig 77), with trefoil arches, is visible on the inside face of the wall. This ornate arrangement is believed to date to the thirteenth century, but was also heavily repaired during the RSAI works carried out during the nineteenth century.

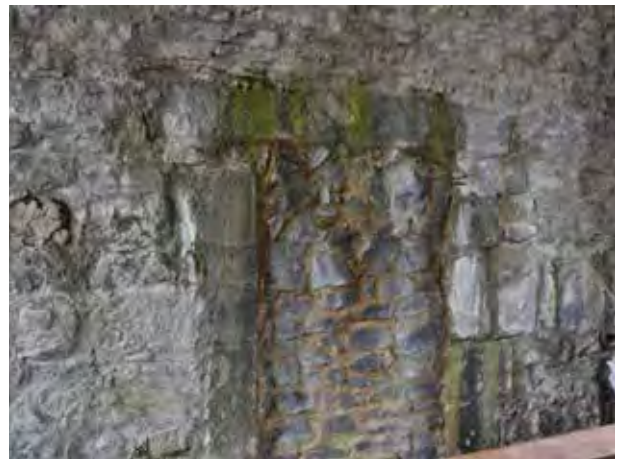
Internally the oratory is damp with poor internal air quality likely due to lack of adequate ventilation and there is evidence of biological growth and damp on the stone lintel of an infilled opening in the north wall. This opening indicates a previous connection between the oratory and the dormitory corridor behind. A relieving arch at low level in this wall may have served a structural purpose, redistributing weight. A display niche has also been inserted in this wall.

Fig 83. Sacristy

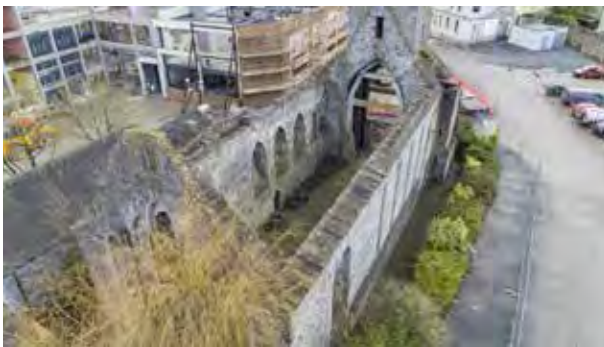
Fig 86. Aerial View of the great Franciscan Friary.

From the drone photography received of the structure, it is clear that the wall tops have vegetation growing along them, and this will also contribute to the loosening and upending of masonry along the pitched gable walls. Vegetation growth on monuments or masonry structures is not necessarily detrimental to the structure but must be managed and monitored to ensure that the roots of woody plants are not starting to loosen or open up joints excessively.

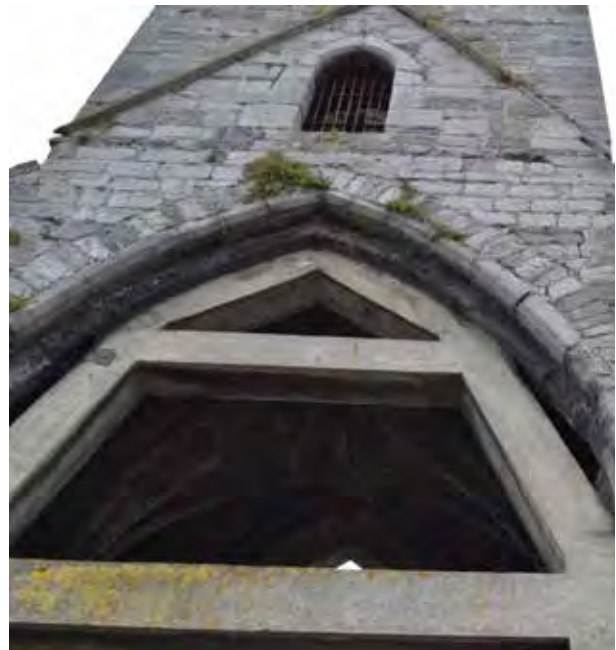
Fig 89. View of the concrete structure supporting the crossing tower

frame may result in de-stabilisation of the tower, and damage to the masonry, in particular to the four carved figures directly abutting the concrete frame on both sides of the tower.

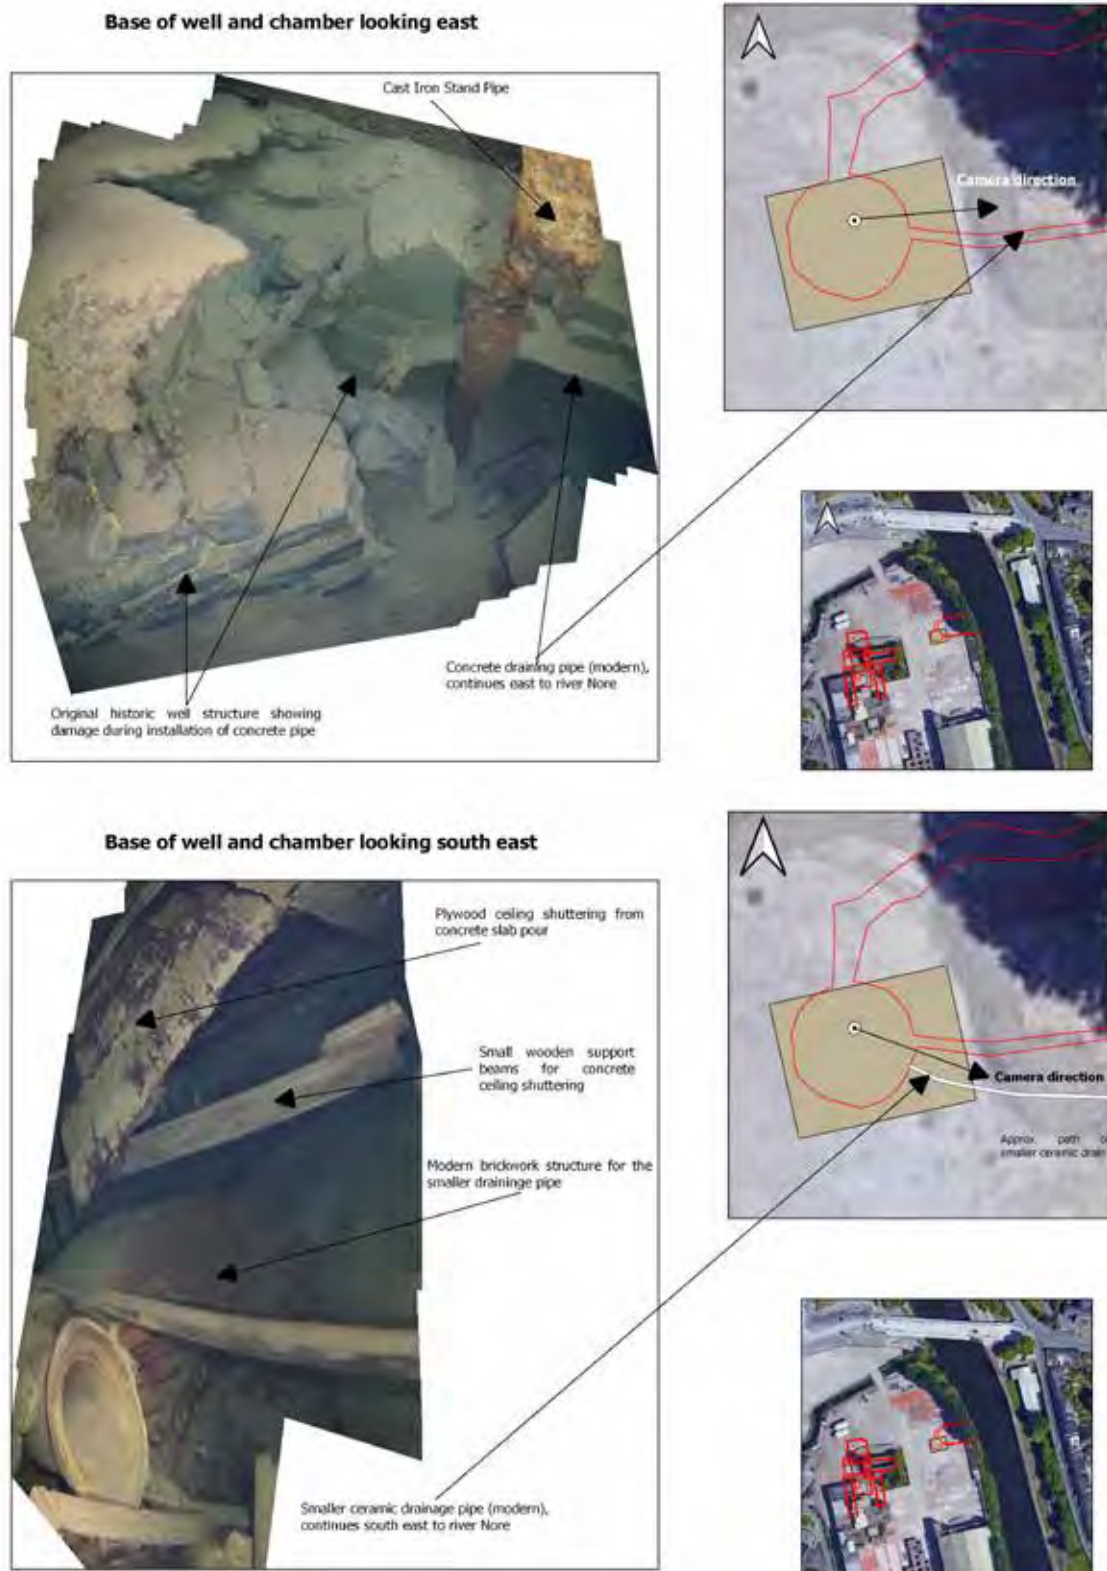
survey of the well, with below ground footage now being processed. Part of the historic well structure are visible though damaged with the insertion of modern concrete and other pipework in later years.

Fig 92. Extracts from the AMS survey of St Francis Well (January 2022)

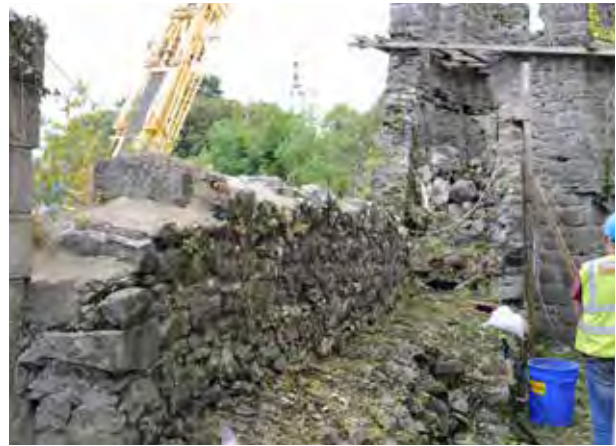
Fig 95. View of the wall walk at Evan's turret prior to works being undertaken.

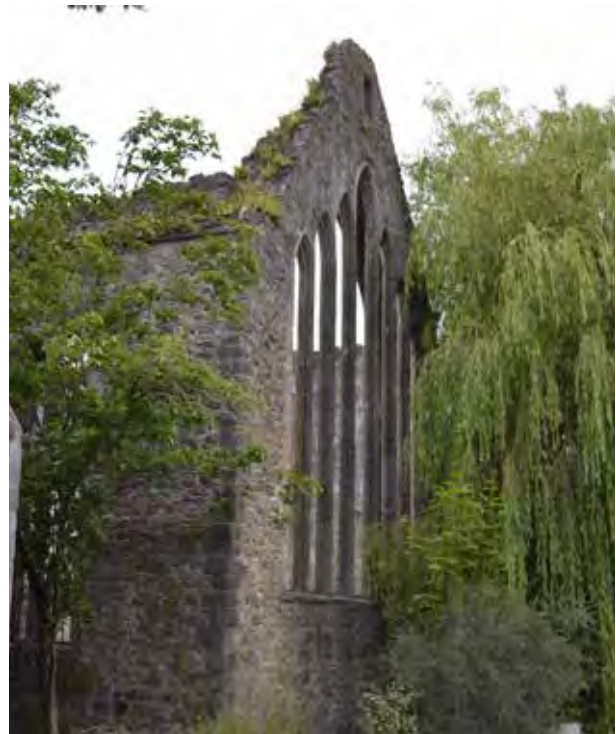
Fig 96. The east window showing the large willow tree encroaching on it.

- Removal of vegetation to the gable walls and rough racking to be introduced to conservation architect / masons specifications.
- Structural laser survey of the east gable window to understand movement in window
- Short term management, longer term removal of the willow tree
- Removal of the cement render from the sill and repointing of masonry below, with insertion of new lime sill or cap stone to the sill, as required.

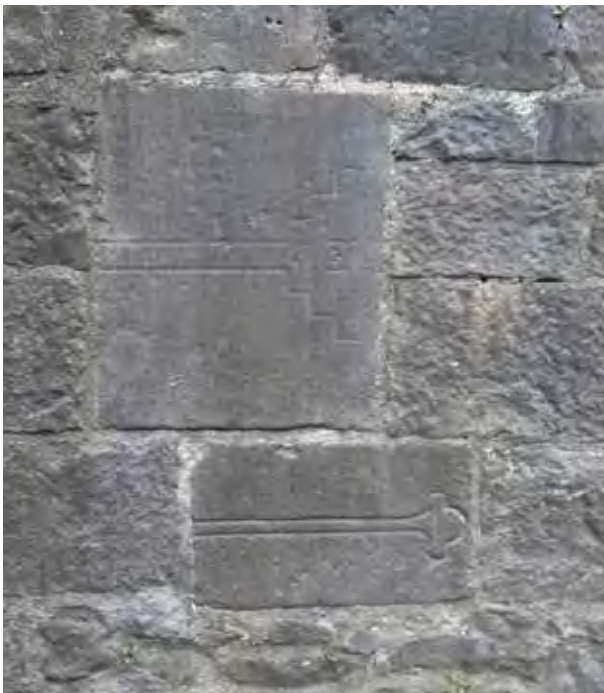
Fig 97. Grave-stones incorporated into the east wall below the large window.

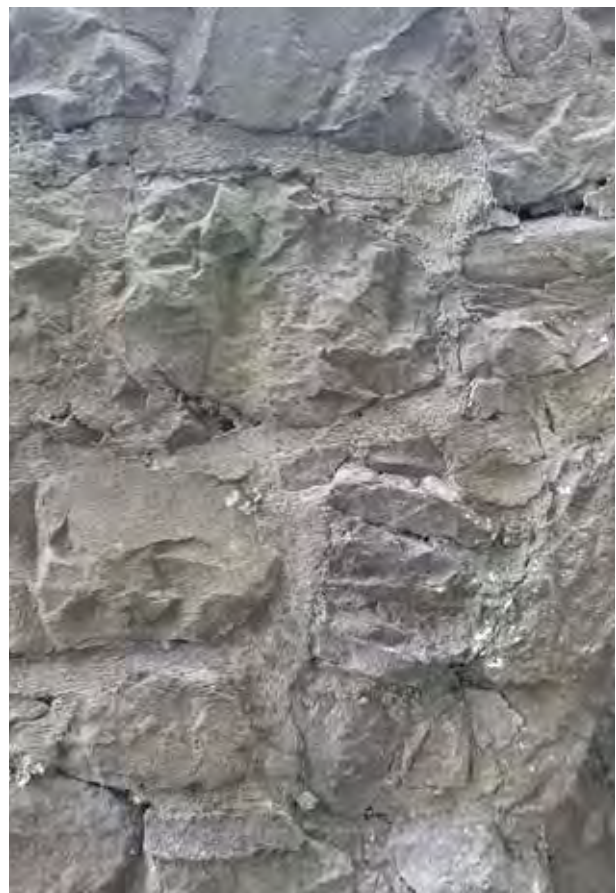
Fig 101. Stones poorly pointed with cement pointing in the east wall.

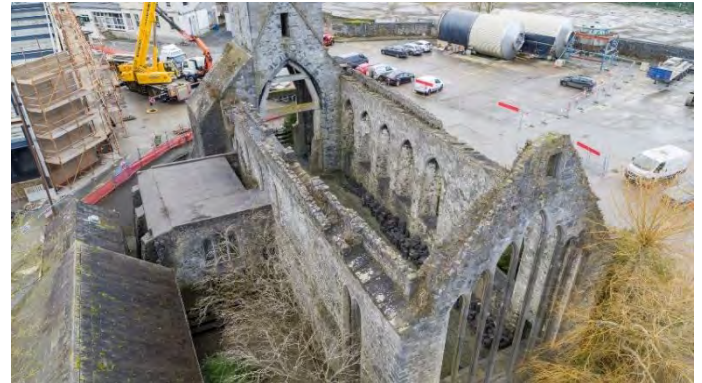
Chancel from drone footage early 2021 looking west

The walls appear to be in reasonable condition overall with no concerning signs of distress. There are different periods construction, repairs and intriguing alterations to be seen particularly to the south side.

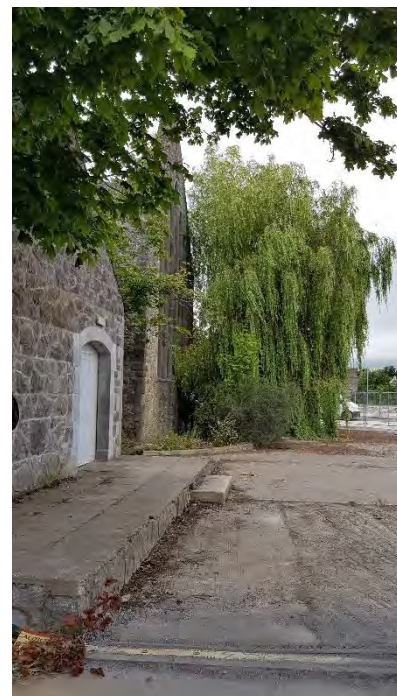
Large weeping willow in close proximity to the east window

3.1.3 Propagate from the weeping willow tree and trim tree back from east gable of abbey.

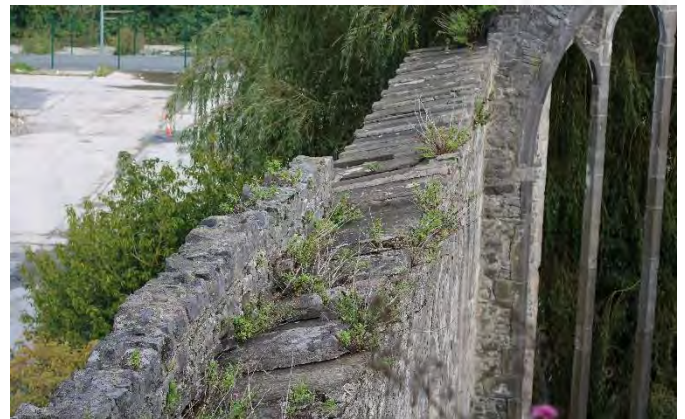
Some vegetation was noted particularly against the inside face of the outer parapet wall where debris is likely collecting where drainage is slowed by having to pass through the small outlets through the parapet masonry.

*North wall top to Chancel as seen from the tower.
Photo c/o Richard Clutterbuck*

3.2.4 Arrange access to the chancel wall tops to assess and repair. This will entail a scaffold to one side of the walls at least and possibly both sides. Vegetation removal and significant repointing will be required at minimum. Thereafter physical access to wall tops can possibly be reduced to every 5 years

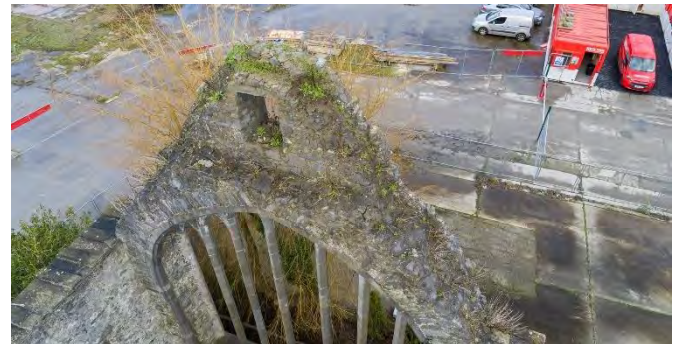
The top of the east gable has much vegetation growing from it and the mortar flaunching can be seen to be cracked.

Top of east gable drone footage early 2021

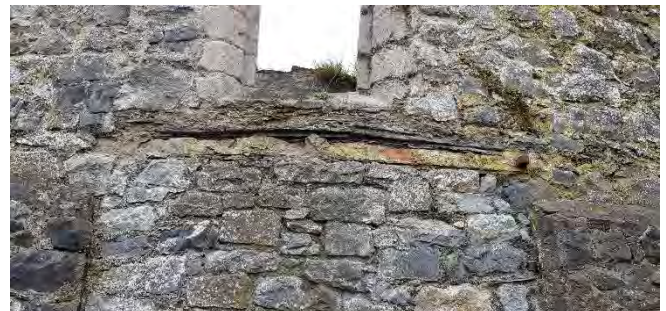
The inbuild corroding steel appears to have been a lintol inserted during the time of the brewery. The door has since been blocked up making the lintel obsolete but also trapping it between masonry. Corroding ferrous metal has the ability to exert significant forces on adjoining structures was it corrodes.

Steel lintel to previous doorway west end of north wall

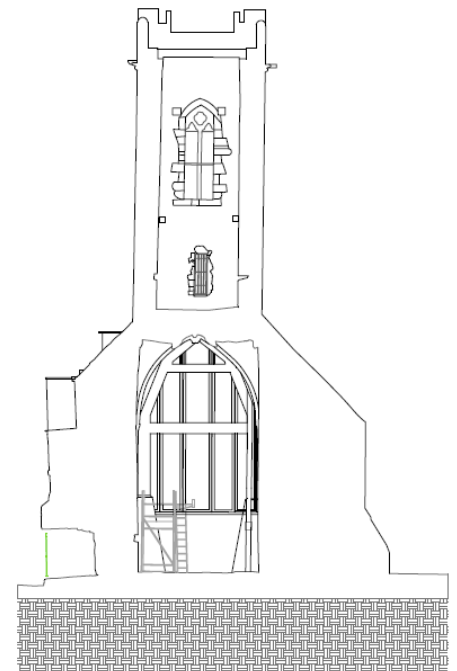
The concrete frames are now 95 years old, the concrete has deteriorated through carbonation allowing moisture to the reinforcement which is causing the concrete to spall from the surface.

Section through Tower looking east, from OPW survey drawings

3.3.1 The concrete frame requires repair within max 5 years. Therefore depending on results of Structural model / analysis instigate repairs of the two concrete frames.

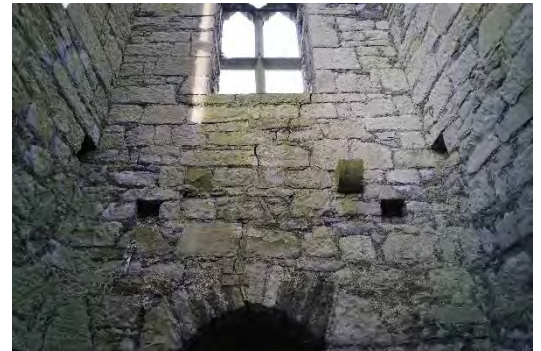
From photographs of the tell tails within the tower it is evident that there is ongoing movement. However this movement does not appear to be alarming and may be as a result of seasonal fluctuations repeating previous cracking at the thinner spandrel points of the tower. The cracking is evident in the south and north faces in the areas where there is less masonry between the sills and heads of the doorways and windows.

*View inside the tower looking north
Photo c/o Chris Corlet*

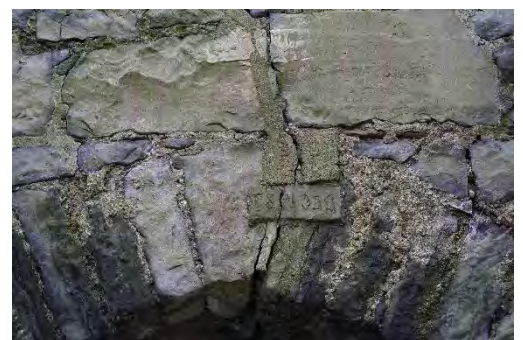
Cement mortar ties were installed in 1949 and 1987 and all but one have cracked but the extent of opening up at the point of cracking appears to be less than 10mm

*Detail of 1949 and 1987 cement mortar
tell tails. Photo c/o Chris Corlet*

3.1.2 Install new crack monitoring devices that allow actual readings to be taken.
